Report of Results: MVA 6423

Arizona Building Dust  
Arizona Dept of Corrections  
Environmental Forensic Microscopy Analysis

Arizona Building Dust – Arizona Dept of Corrections  
Environmental Forensic Microscopy Analysis

Arizona Building Dust  
General Services Building  
Environmental Forensic Microscopy Analysis

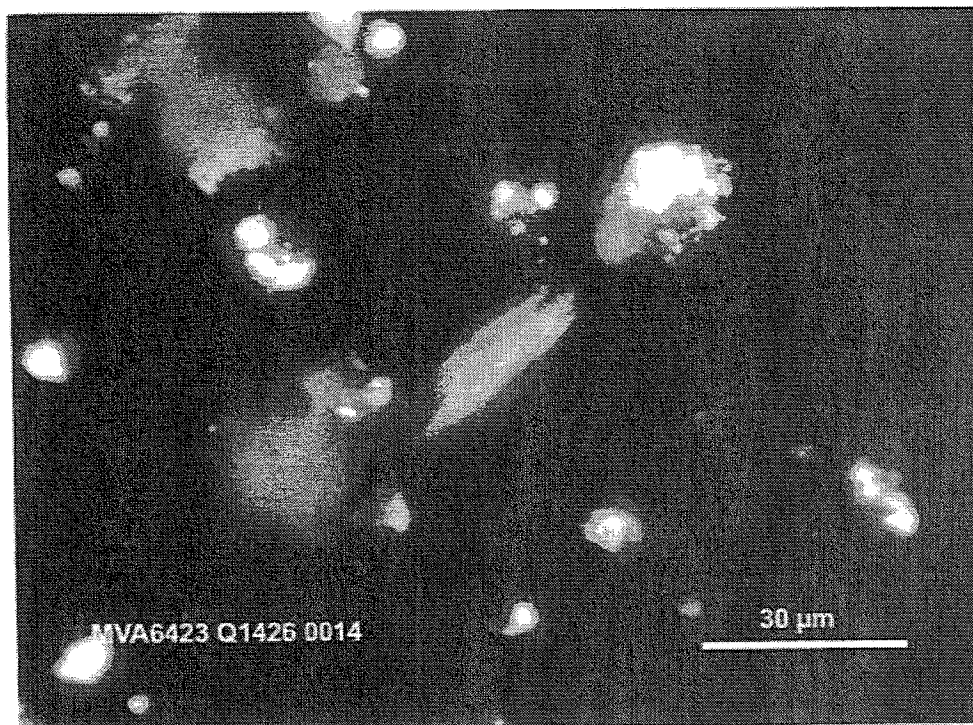
The dusts in Samples Q1422 through Q1427 have the same general appearance. They are all fine brown granular dusts. They contain vermiculite, gypsum and chrysotile asbestos (Figures 1 through 3). The particles in the dusts are consistent with normal indoor building dusts<sup>1,2</sup> (including cotton and other fibers) mixed with fallout from the fireproofing (containing vermiculite, gypsum and chrysotile) that is located in the building.

**Figure 1.** Polarized light microscope image (darkfield mode) of a chrysotile bundle in Sample Q1426.

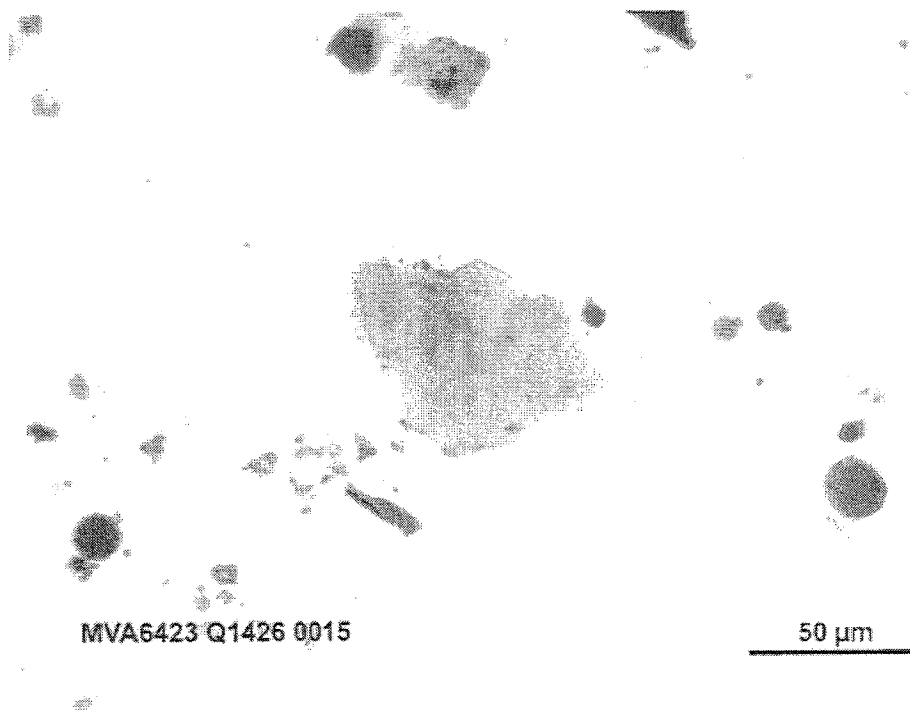
**Figure 2.** Polarized light microscope image (brightfield mode) of a vermiculite flake in Sample Q1426. Aggregates of gypsum are also evident.

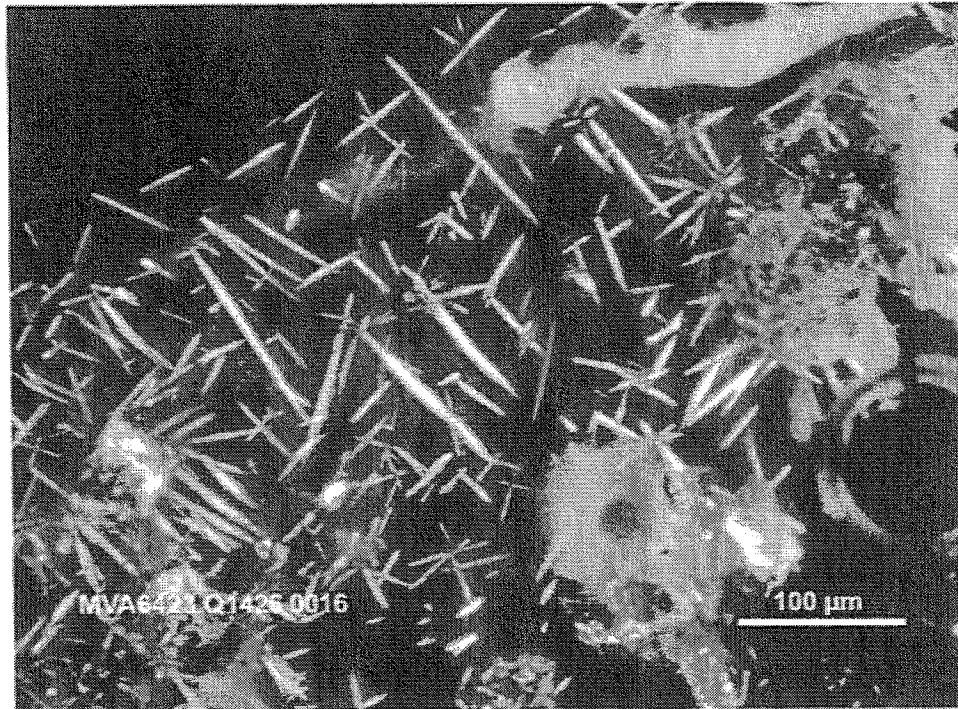
**Figure 3.** Polarized light microscope image (darkfield mode) of gypsum crystals in Sample Q1426.

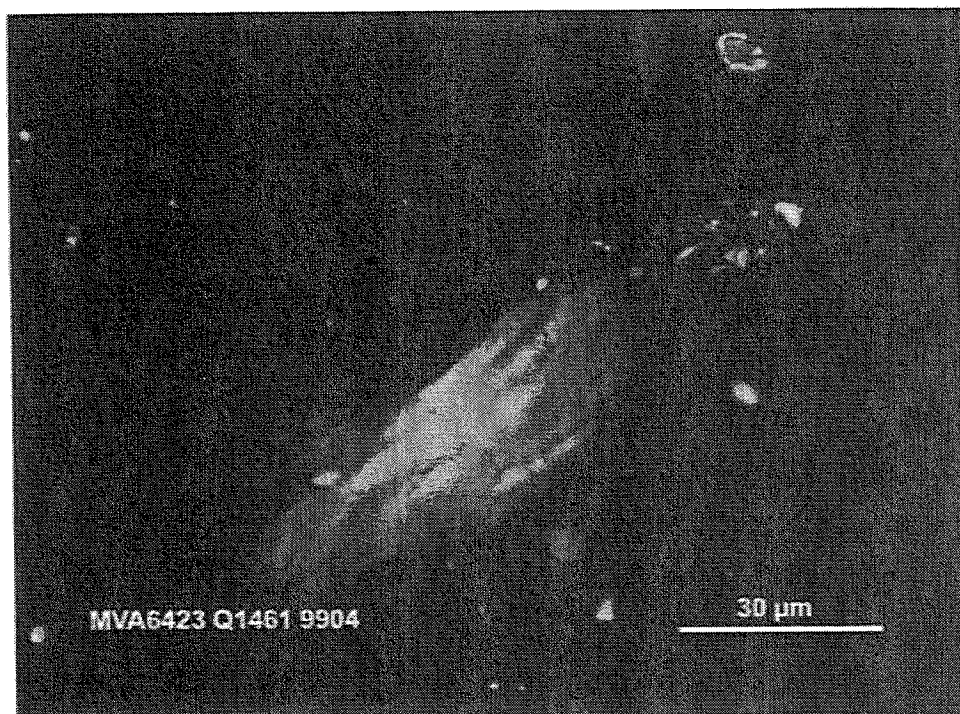
The dust in Sample Q1461 is a fine brown granular dust with evident fibers. It contains vermiculite, montmorillonite and chrysotile asbestos (Figures 1 through 3). The particles in the dusts are consistent with normal indoor building dusts<sup>1,2</sup> (including cotton and other fibers) mixed with fallout from the acoustical plaster (containing vermiculite, montmorillonite clay and chrysotile) that is located in the building.

**Figure 1.** Polarized light microscope image (darkfield mode) of a chrysotile bundle among gypsum and vermiculite flakes in Sample Q1461.

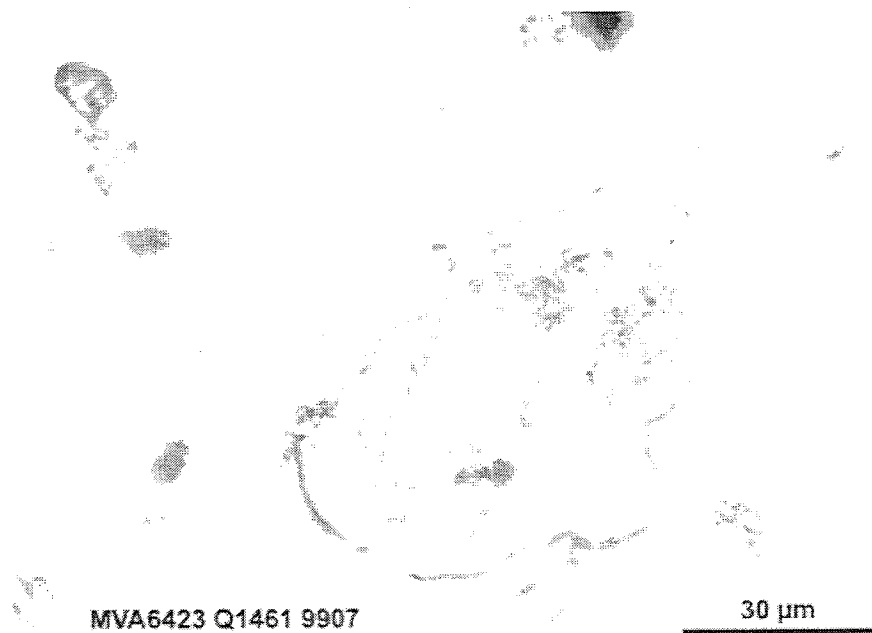
**Figure 2.** Polarized light microscope image (brightfield mode) of a vermiculite flake in Sample Q1461.

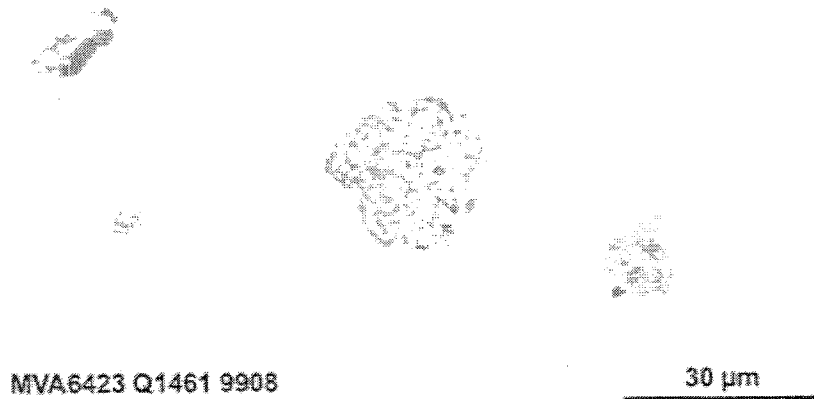
Figure 3. Polarized light microscope image (brightfield mode) of montmorillonite clay in Sample Q1461.
